**From CEO Jane Cutler**

Concern over state of electrical equipment

Potential danger from tensioner wire failures

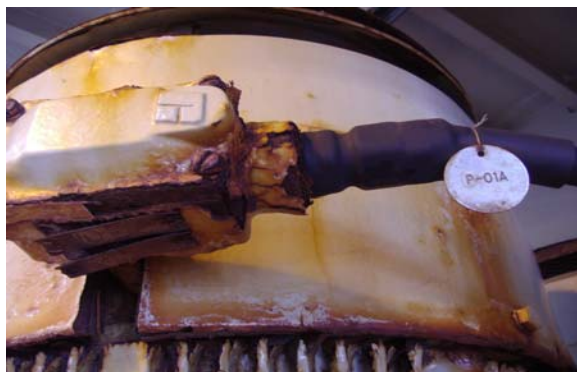
- incorrectly rated electrical equipment for the location
- corrosion of equipment (eg motors, instruments, junction boxes)
- non- rated portable equipment in hazardous areas
- electrical wiring not properly terminated and, in some cases, still 'live'

Most of the safety issues identified have occurred on ageing facilities where maintenance is lacking. However, there have been some instances of incorrectly rated hazardous area electrical equipment being installed in hazardous zones on newer facilities.

Examples of photos taken during NOPSA inspections. Corroded junction box on pump motor (left). Poorly maintained light fitting in process area (right).

Electrical equipment used in hazardous areas should receive regular specialist inspection, maintenance and re-certification.

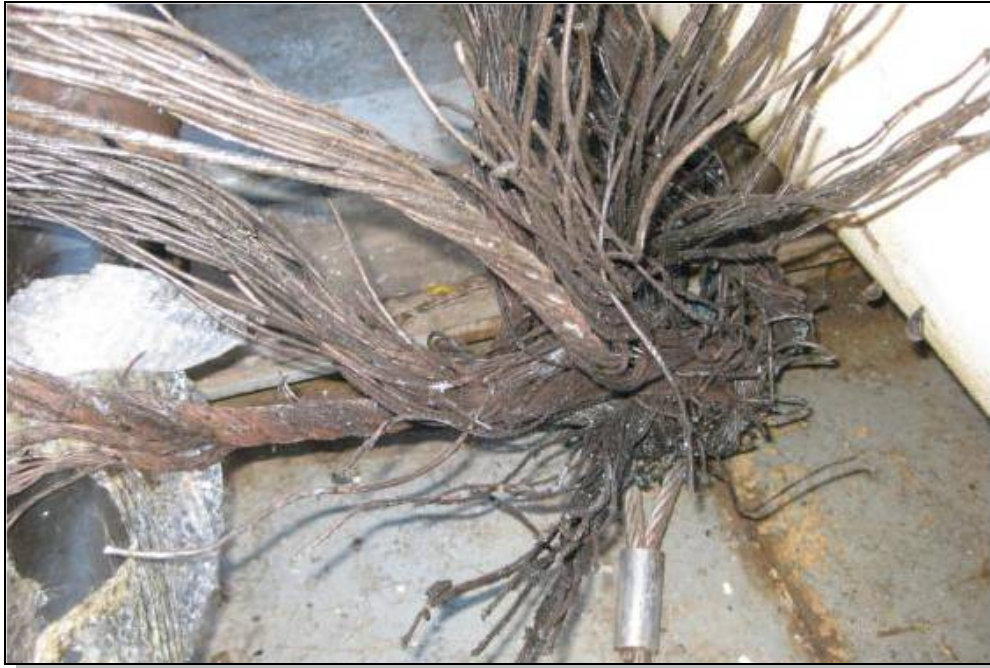
Photo from a recent incident on a facility in Australian waters

NOPSA has received a range of reports recently involving tensioner wire failure. As can be seen from the photograph, above, when the wire rope parts it can be like an explosion and can pose a hazard to nearby personnel. Also, the sudden release of the tensioner load can cause subsequent tensioner failure if the unit is not properly maintained as described in a previous [safety alert](#)² issued by NOPSA.

A key factor which has been noted by operators in analysis of these incidents includes the need for wire rope fatigue management to take into account local 'met-ocean' conditions.

Some actions taken by operators after these incidents include:

- developing a strategy for determining useable life, including destructive testing
- immediate inspection and replacement of wire rope on all other tensioners
- changing from a slip and cut programme to a fixed length programme.
