**From CEO John Clegg**

## Industry matters

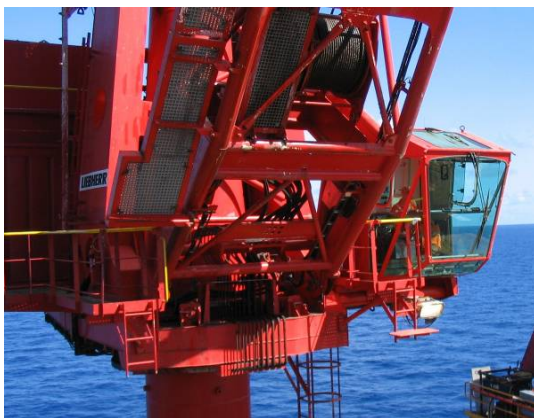
*No drops protection*

Operators are advised to carry out an assessment to confirm crane overhead windows are physically protected and not just reliant on safety glass. NOPSA has produced a [safety alert](#)<sup>3</sup> drawing attention to an American Petroleum Institute recommendation that crane cabs with overhead windows have a grating or other protection over the window to prevent debris from falling on the operator.

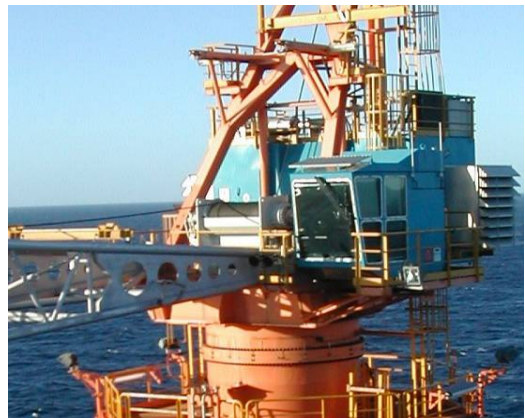
*With drops protection*
